RFTR17166

#### TEST REPORT

**Numunenin adı ve tarifi** : Single Side Partition Wall System Consisting of Three Layer of MgO Panels –  
*Name and identity of test sample* “NevPanel, DragonBoardTürkiye, MagnumBoard”

Fire resistance test, in conformity with the general requirements of standards EN1363-1:2012, with substitute or additional methods of standard EN 1363-2:1999 and with the particular requirements of standard EN 1364-1:2015 "Fire resistance tests for non- loadbearing elements- Part 1:Walls".

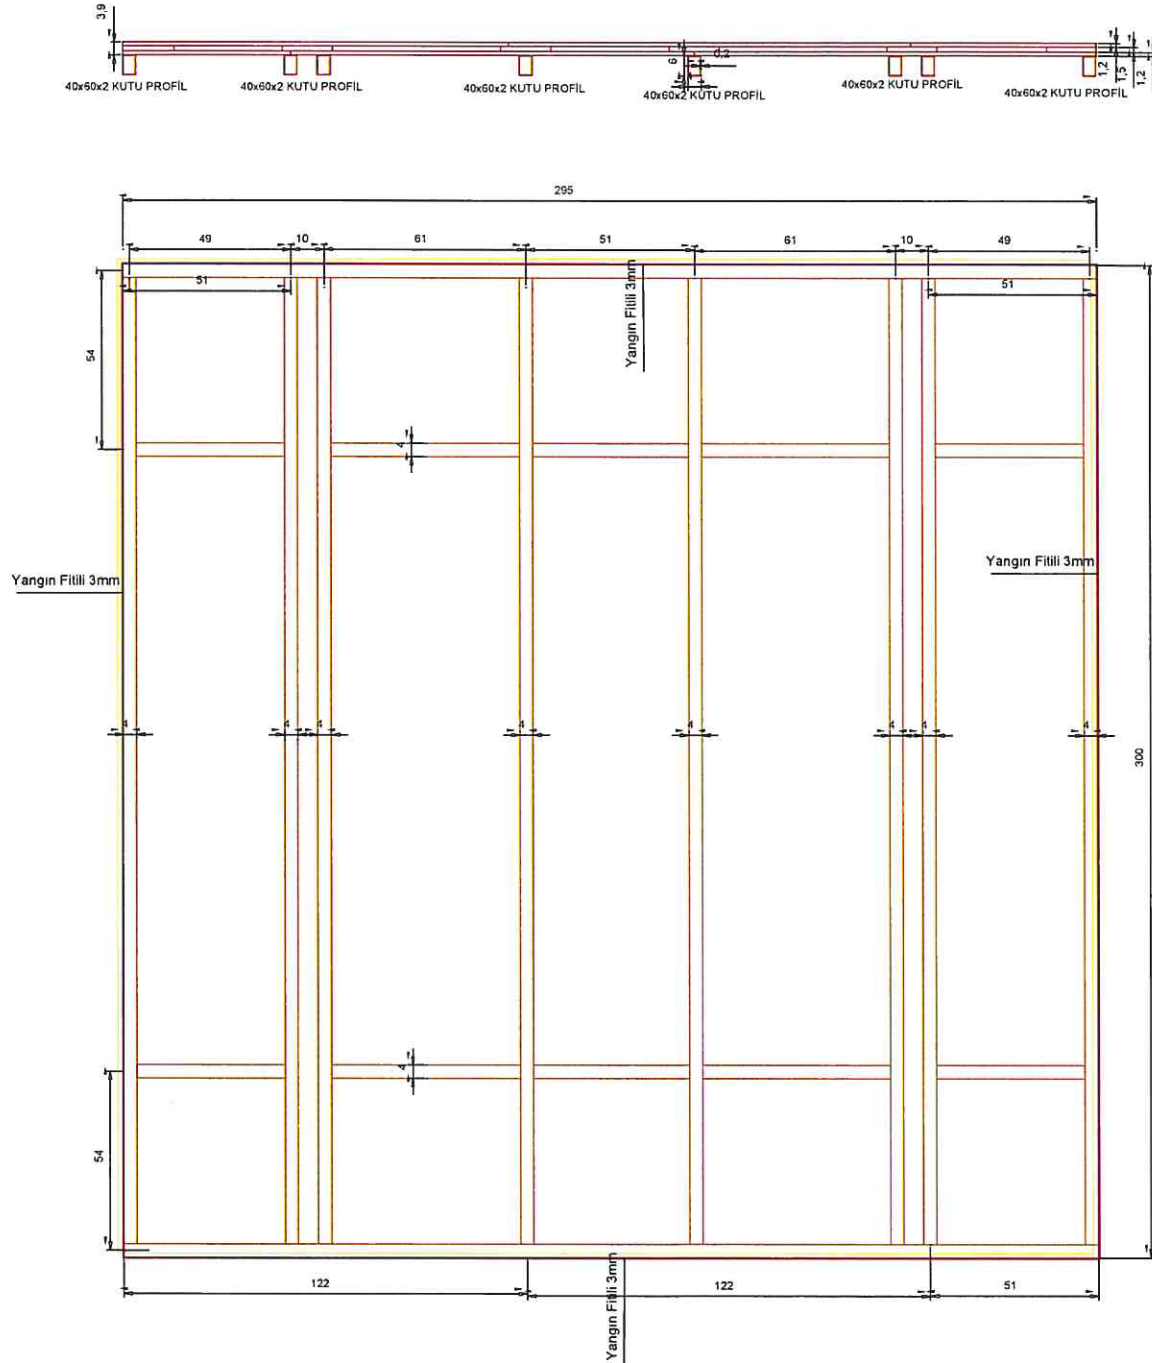
Figure 1: Details of framework profiles

#### 3.3.1. Framework

##### • Edge and intermediate studs:

- Type : Box shaped profile - mild steel.
- Dimensions : 2920 x 40 x 60 x 2 mm (h x d x w x t)
- Locations : Distances between each profile were respectively 490, 100, 610, 510, 610 and 100 mm.

- Top and bottom rails:
  - Type : Box shaped profile - mild steel.
  - Dimensions : 3000 x 40 x 60 x 2 mm (l x d x w x t)
  - Locations : Top and bottom side of the panel

- Intermediate horizontal rails:
  - Type : Box shaped profile - mild steel.
  - Dimensions : 450 x 40 x 60 x 2 mm (l x d x w x t) (4 pcs.)  
450 x 40 x 60 x 2 mm (l x d x w x t) (4 pcs.)  
450 x 40 x 60 x 2 mm (l x d x w x t) (2 pcs.)

- Locations : Top and bottom distance were approximately 540 mm. Profiles were fixed with welding

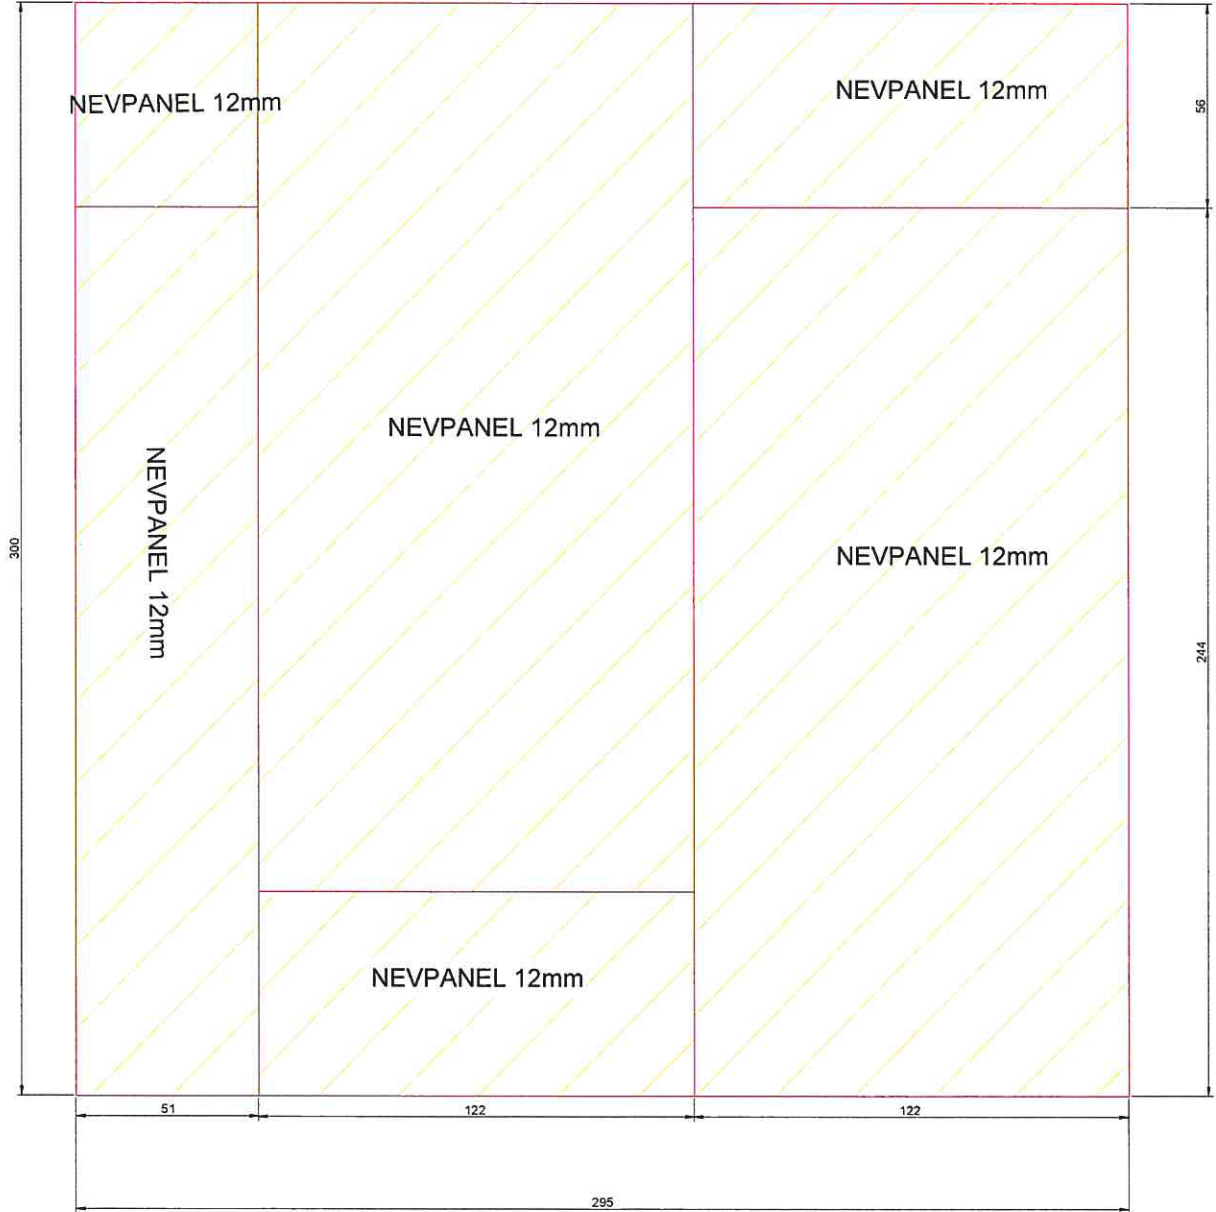
1.KAT PANEL GÖRÜNÜMÜ

Figure 2: Details of 1. layer panels

- First layer:
  - o panels next to the free edge : 1220 x 560 mm (w x h) – at top  
1220 x 2440 mm (w x h) – at bottom
  - o panels in the middle : 1220 x 2440 mm (w x h) – at top  
1220 x 560 mm (w x h) – at bottom

- o panels next to the fixed edge: 510 x 560 mm (w x h) – at top  
510 x 2440 mm (w x h) – at bottom
- Second layer:
  - o panels next to the free edge : 510x 2440 mm (w x h) – at top  
510 x 560 mm (w x h) – at bottom

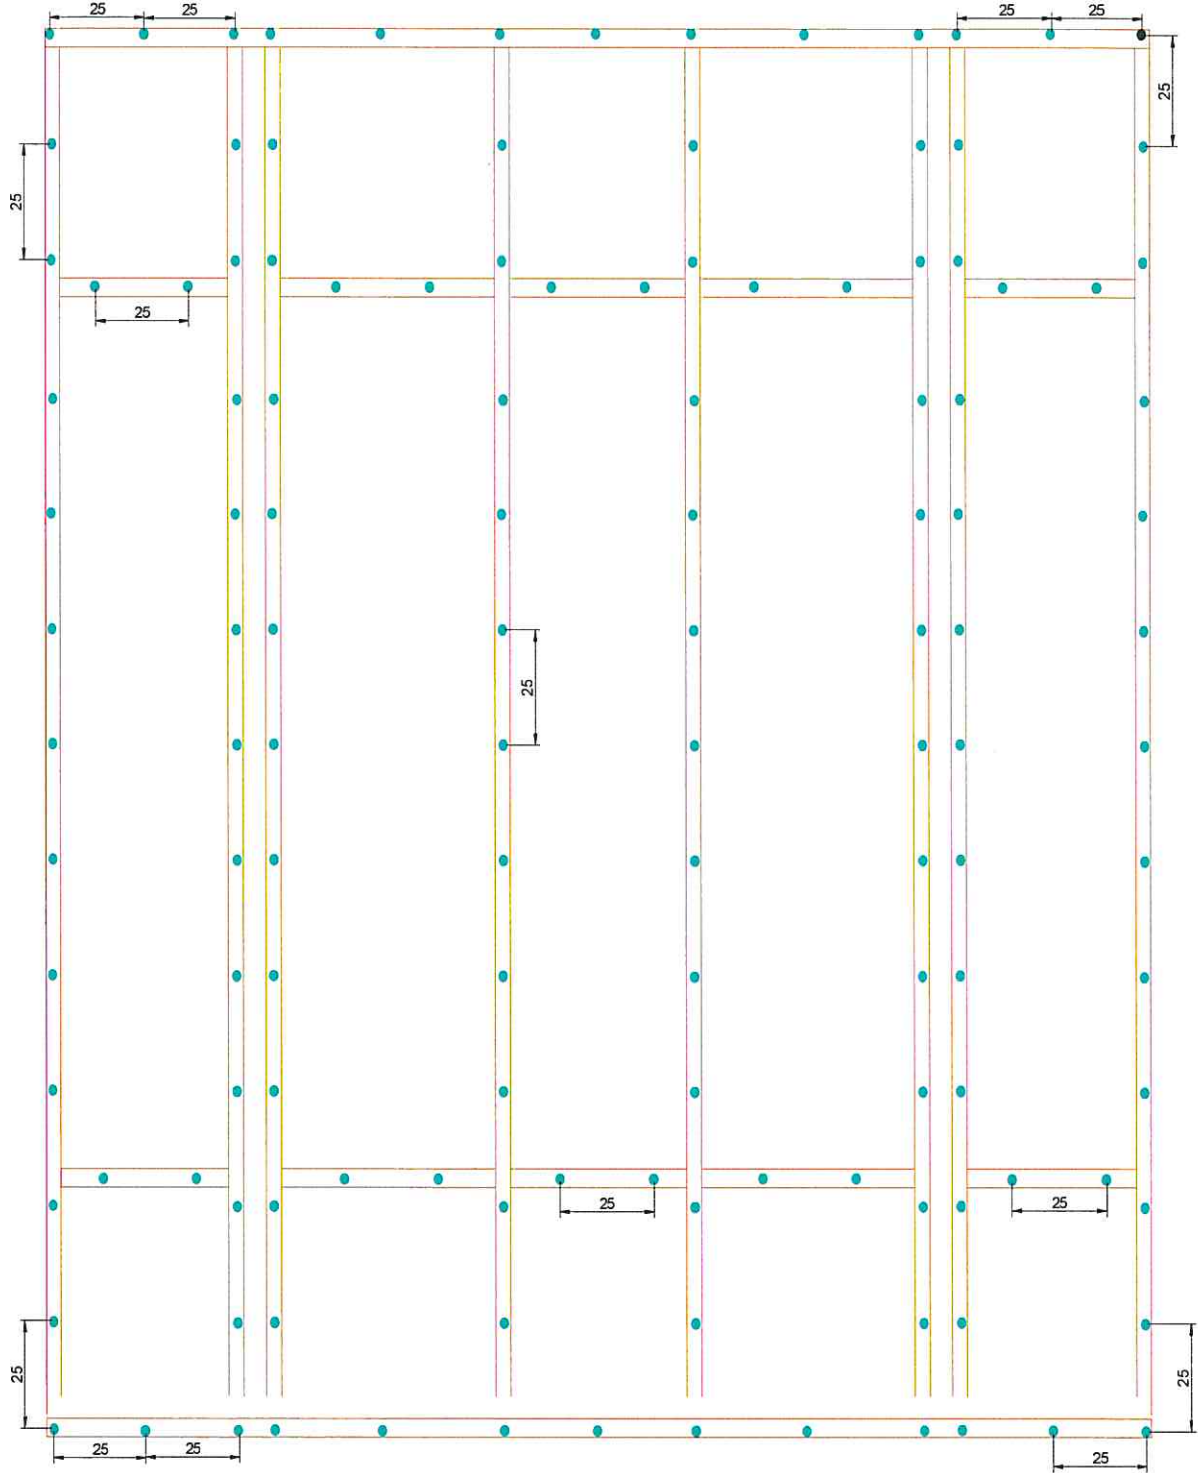
Figure 3: Location of screws of 1. layer panels

- o Dimensions : 39 x 32 mm (Ø x l)
    - o Locations : 13 pcs. at top and bottom of the first profiles, started at 250 mm from edge of the frame c.t.c. distances were respectively 250, 100, 300, 300, 250, 250, 300, 300, 100, 250 and 250 mm

10 pcs. at middle and intermediate of the first profiles, started at 140 mm from edge of the frame c.t.c. distances were respectively 250 and 400 mm

11 pcs. at vertically of the first profiles, started at 250 mm from edge of the frame c.t.c. distances were respectively 250 mm
  - Type: Galvanized steel screw – self-drilling screw
    - o Dimensions : 40 x 60 mm (Ø x l)
    - o Locations : 13 pcs. at top and bottom of the second profiles, started at 250 mm from edge of the frame c.t.c. distances were respectively 250, 100, 300, 300, 250, 250, 300, 300, 100, 250 and 250 mm

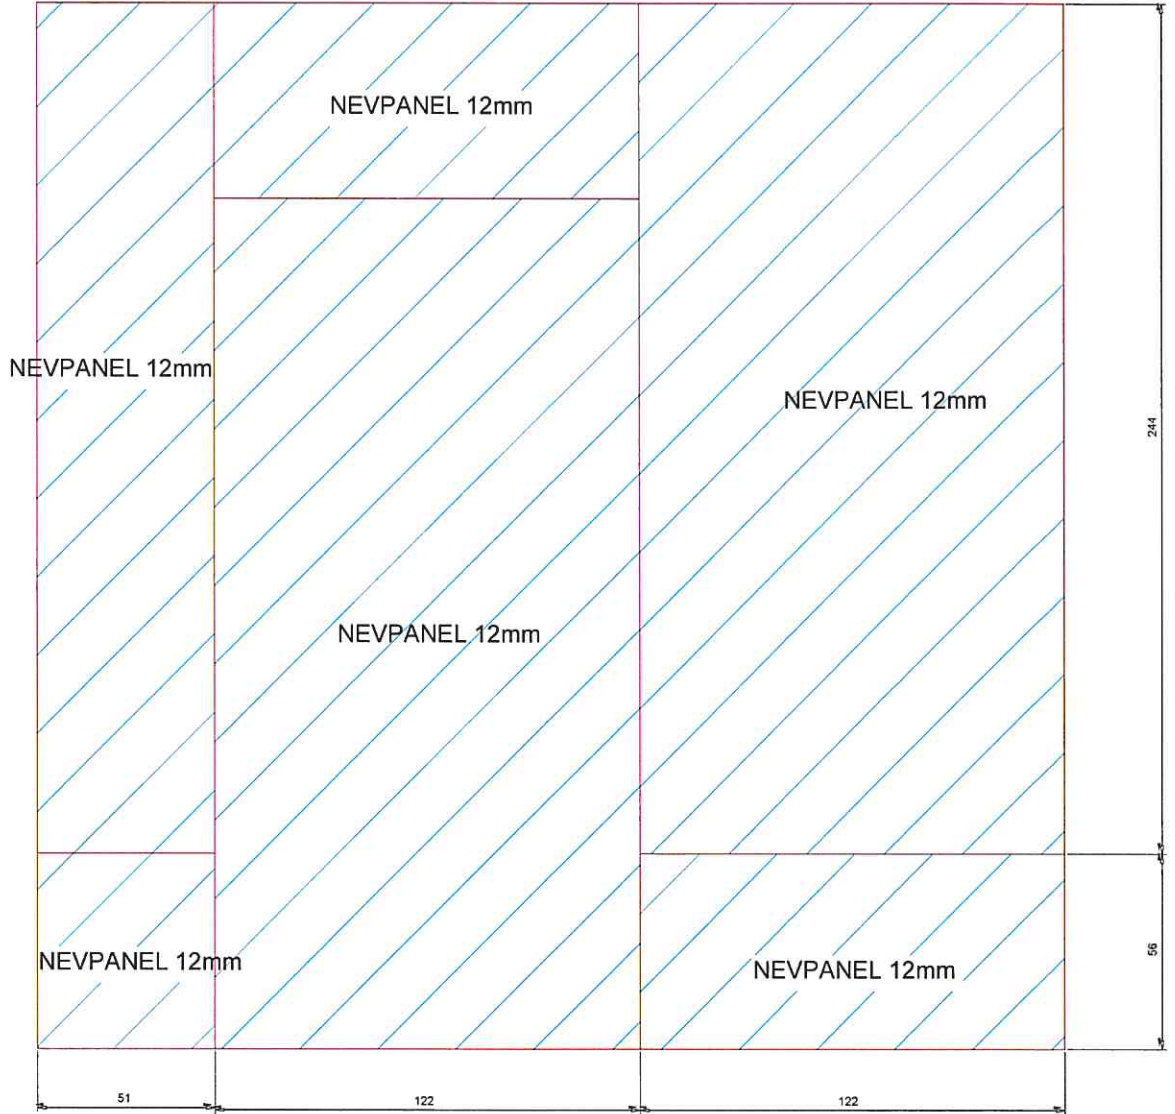
## 2.KAT PANEL GÖRÜNÜMÜ

Figure 4: Details of 2. layer panels

- o panels in the middle : 1220 x 560 mm (w x h) – at top  
1220 x 2440 mm (w x h) – at bottom
  - o panels next to the fixed edge: 1220 x 2440 mm (w x h) – at top  
1220 x 560 mm (w x h) – at bottom

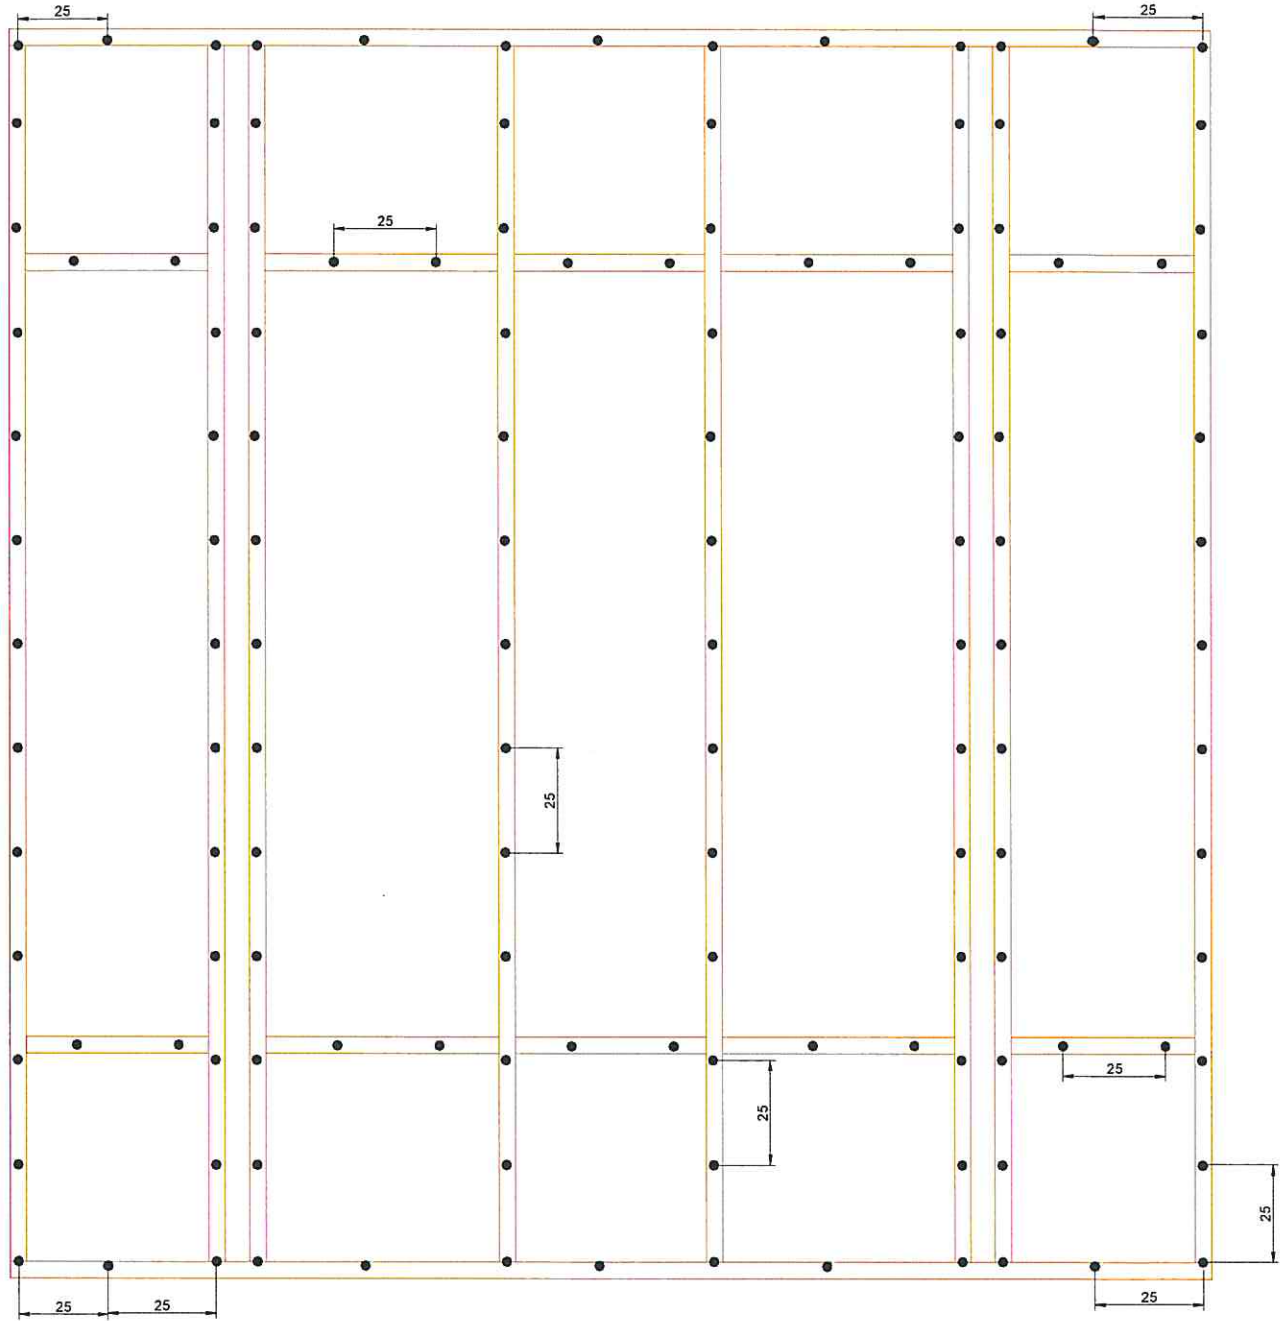
Figure 5: Location of screws of 2. layer panels

10 pcs. at middle and intermediate of the second profiles, started at 125 mm from edge of the frame c.t.c. distances were respectively 300, 350, 300, 300, 300, 300, 300, 350 and 300 mm

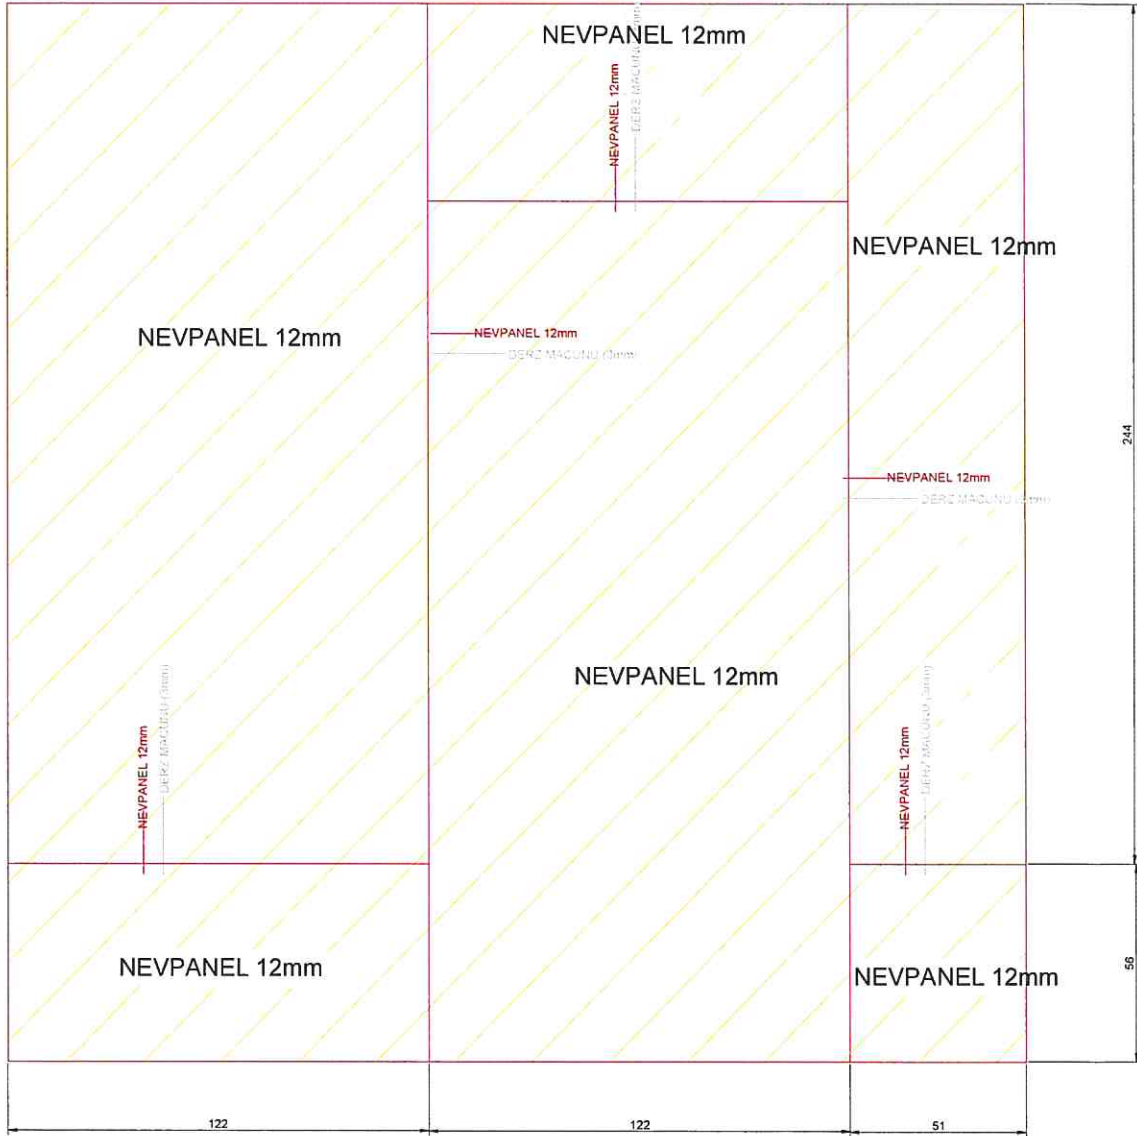
### 3.KAT PANEL GÖRÜNÜMÜ

Figure 6: Details of 3. layer panels

- Third layer:
  - o panels next to the free edge : 1220 x 2440 mm (w x h) – at top  
1220 x 560 mm (w x h) – at bottom
  - o panels in the middle : 1220 x 560 mm (w x h) – at top  
1220 x 2440 mm (w x h) – at bottom

- o panels next to the fixed edge: 510 x 2440 mm (w x h) – at top  
510x 560 mm (w x h) – at bottom
- Fixing: The panels were fixed to the framework.
  - Type: Galvanized steel screw – self-drilling screw

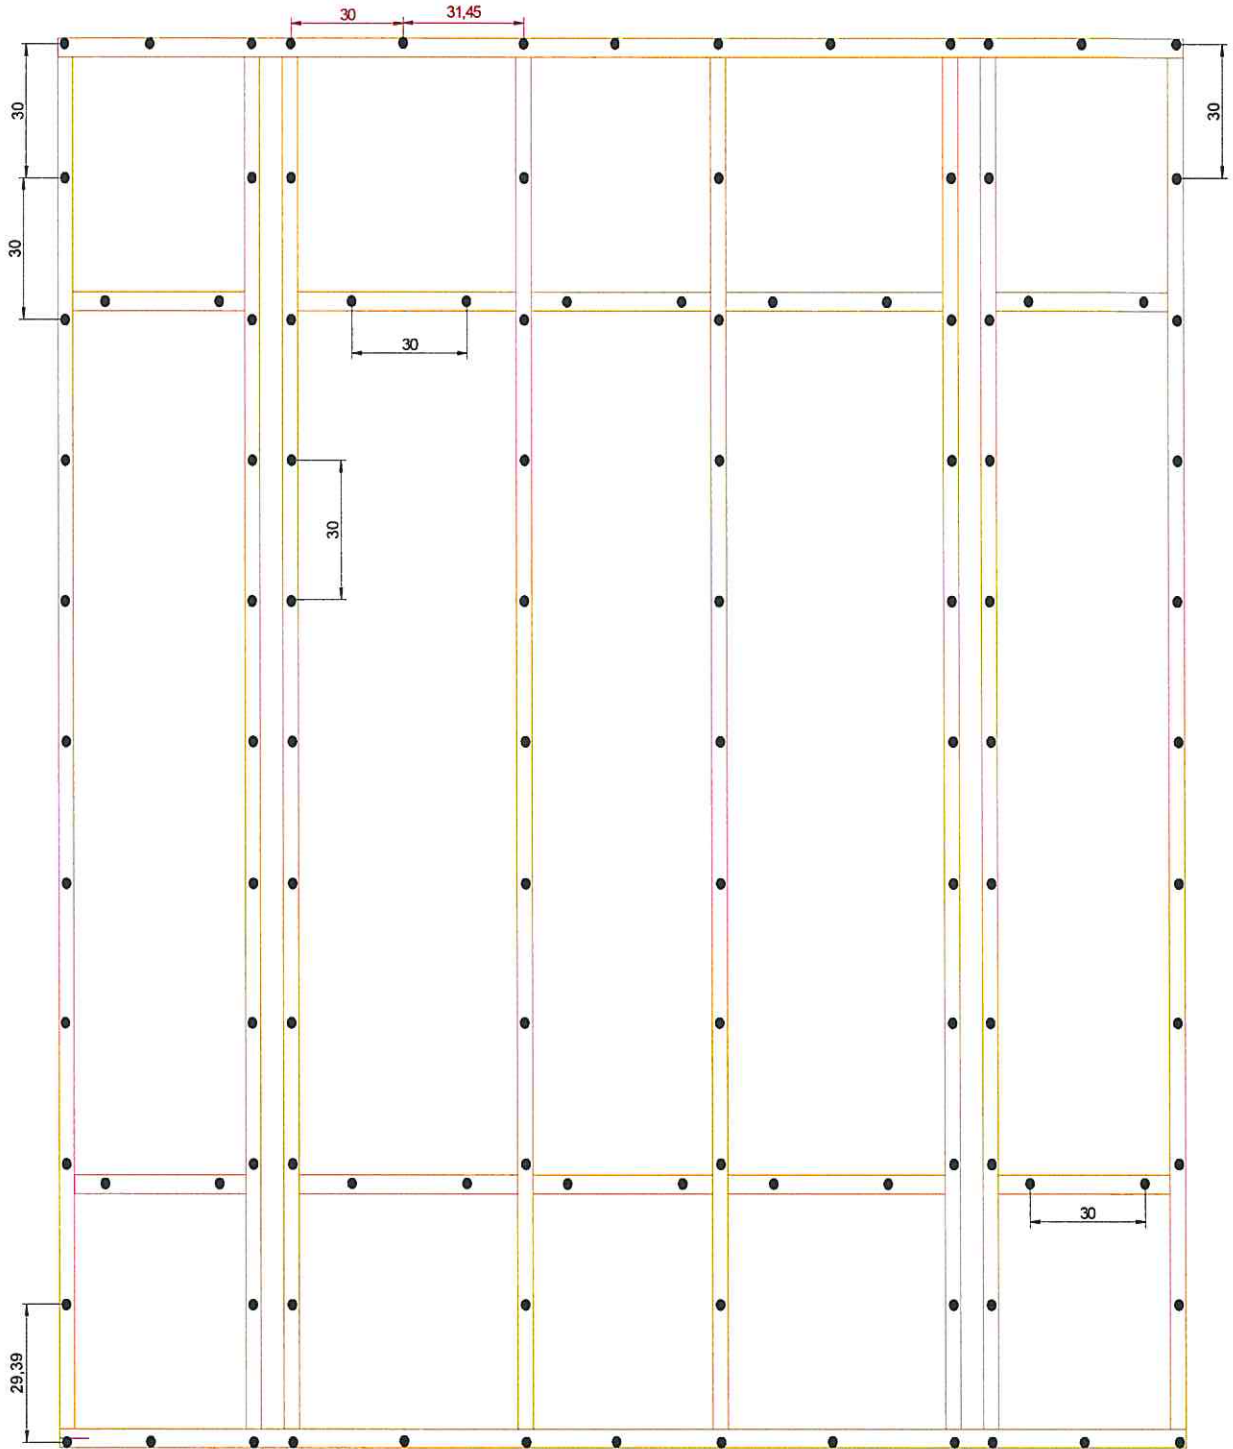
Figure 7: Location of screws of 3. layer panels

– Type: Galvanized steel screw – self-drilling screw

o Dimensions : 40 x 60 mm (Ø x l)

o Locations : 13 pcs. at top and bottom of the third profiles, started at 250 mm from edge of the frame c.t.c. distances were respectively 250, 100, 300, 300, 250, 250, 300, 300, 100, 250 and 250 mm

10 pcs. at middle and intermediate of the third profiles, started at 125 mm from edge of the frame c.t.c. distances were respectively 300, 350, 300, 300, 300, 300, 300, 350 and 300 mm

9 pcs. at middle and intermediate of the third profiles, started at 300 mm from edge of the frame c.t.c. distances were respectively 300 mm

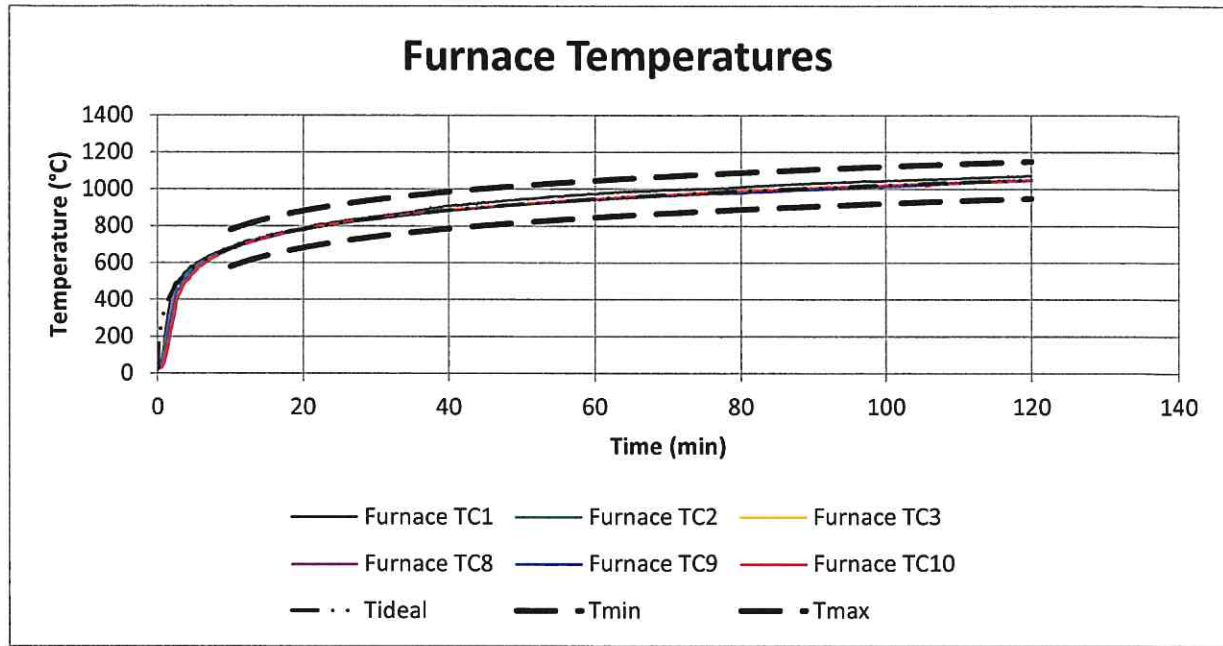
Figure A1: Furnace Temperatures

The heating of the furnace followed the standard fire curve, as specified in the standard EN 1363-1:2012.

- Ambient temperatures inside the furnace with six plate thermocouples (Furnace TC1 to TC6), evenly distributed over the directly heated surface (see figure A1).
- The pressure in the furnace, measured at a height of 2,9 meter above the furnace floor level (see figure A3).
- Ambient temperature in the laboratory (see figure A4)
- The surface temperatures on the unexposed side of the test specimen (TC 3 up to TC18, see figure B2-B3).
- Deflection measurements of the test specimen (see figure B4 and Table B1).
- There was no need to use roving thermocouple.
- The positions of the thermocouple and displacement measurements are given in figure B1.

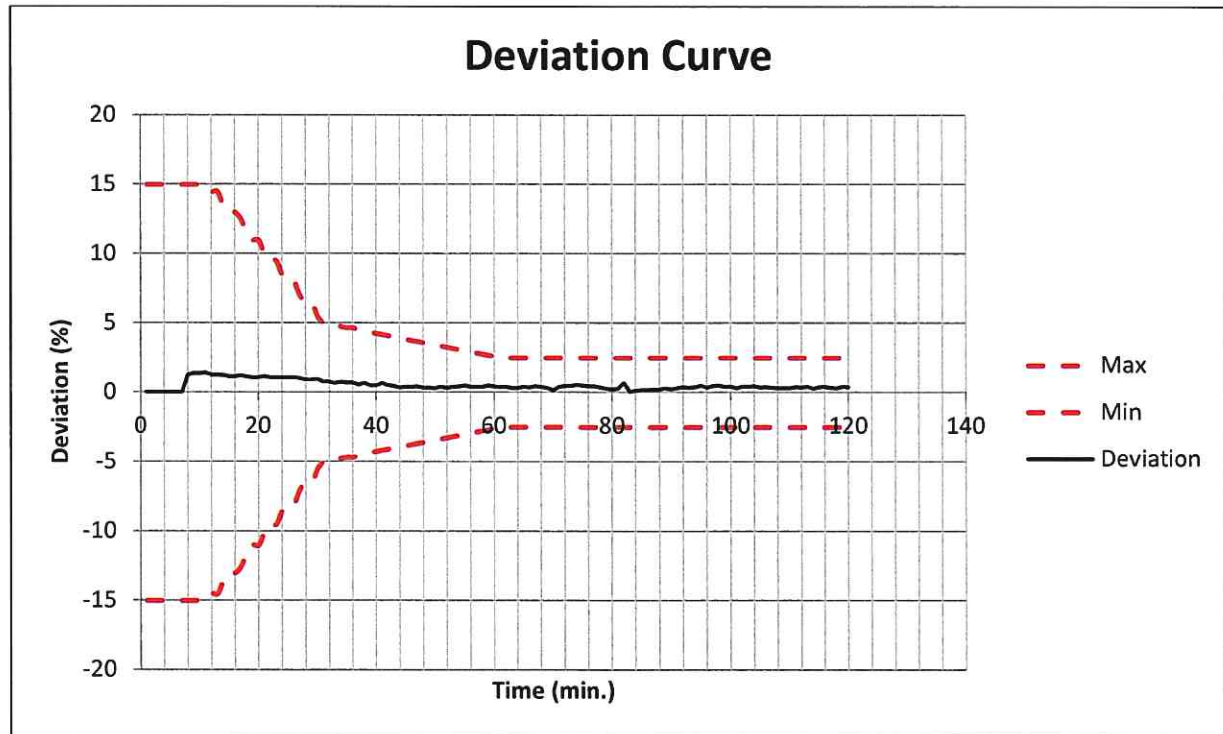
Figure A2: Deviation of furnace temperature

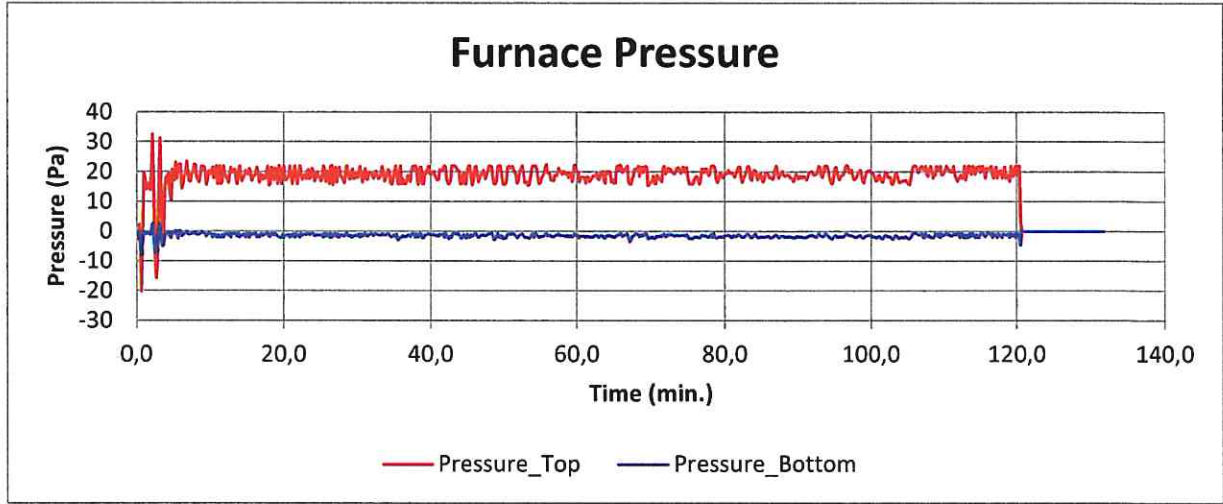
Figure A3: Pressure in the furnace

The target overpressure in the furnace was 0 Pa at 500 mm above floor level and 19 Pa at the top of the test specimen.

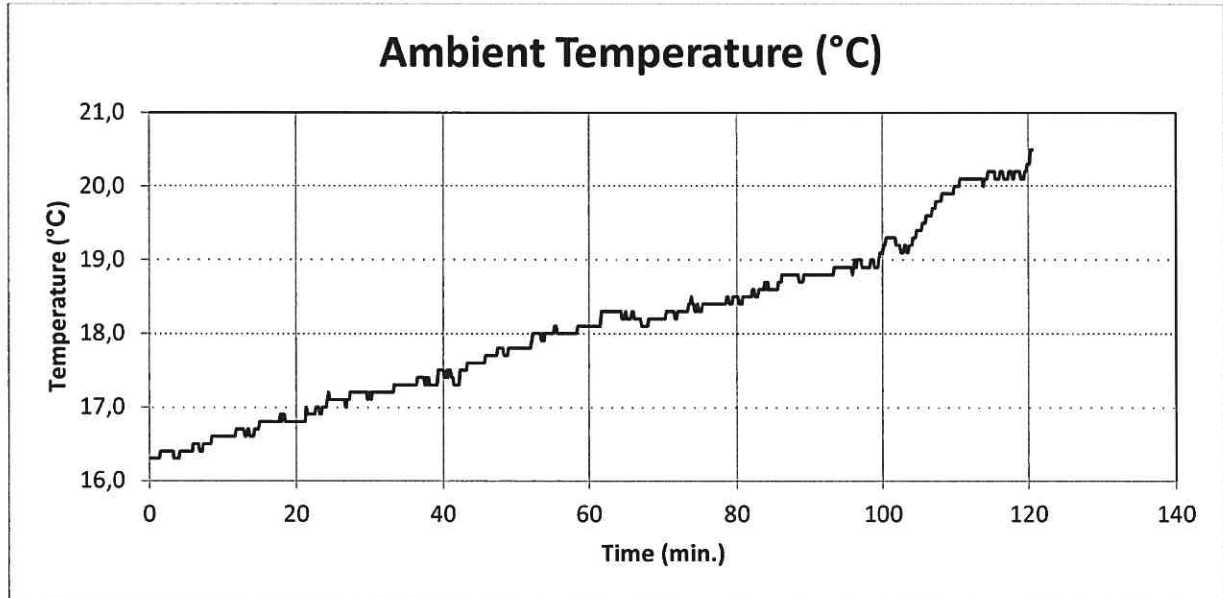
Figure A4: Ambient temperature at laboratory

During the heating the temperature in the laboratory complied with the standard EN 1363-1:2012.

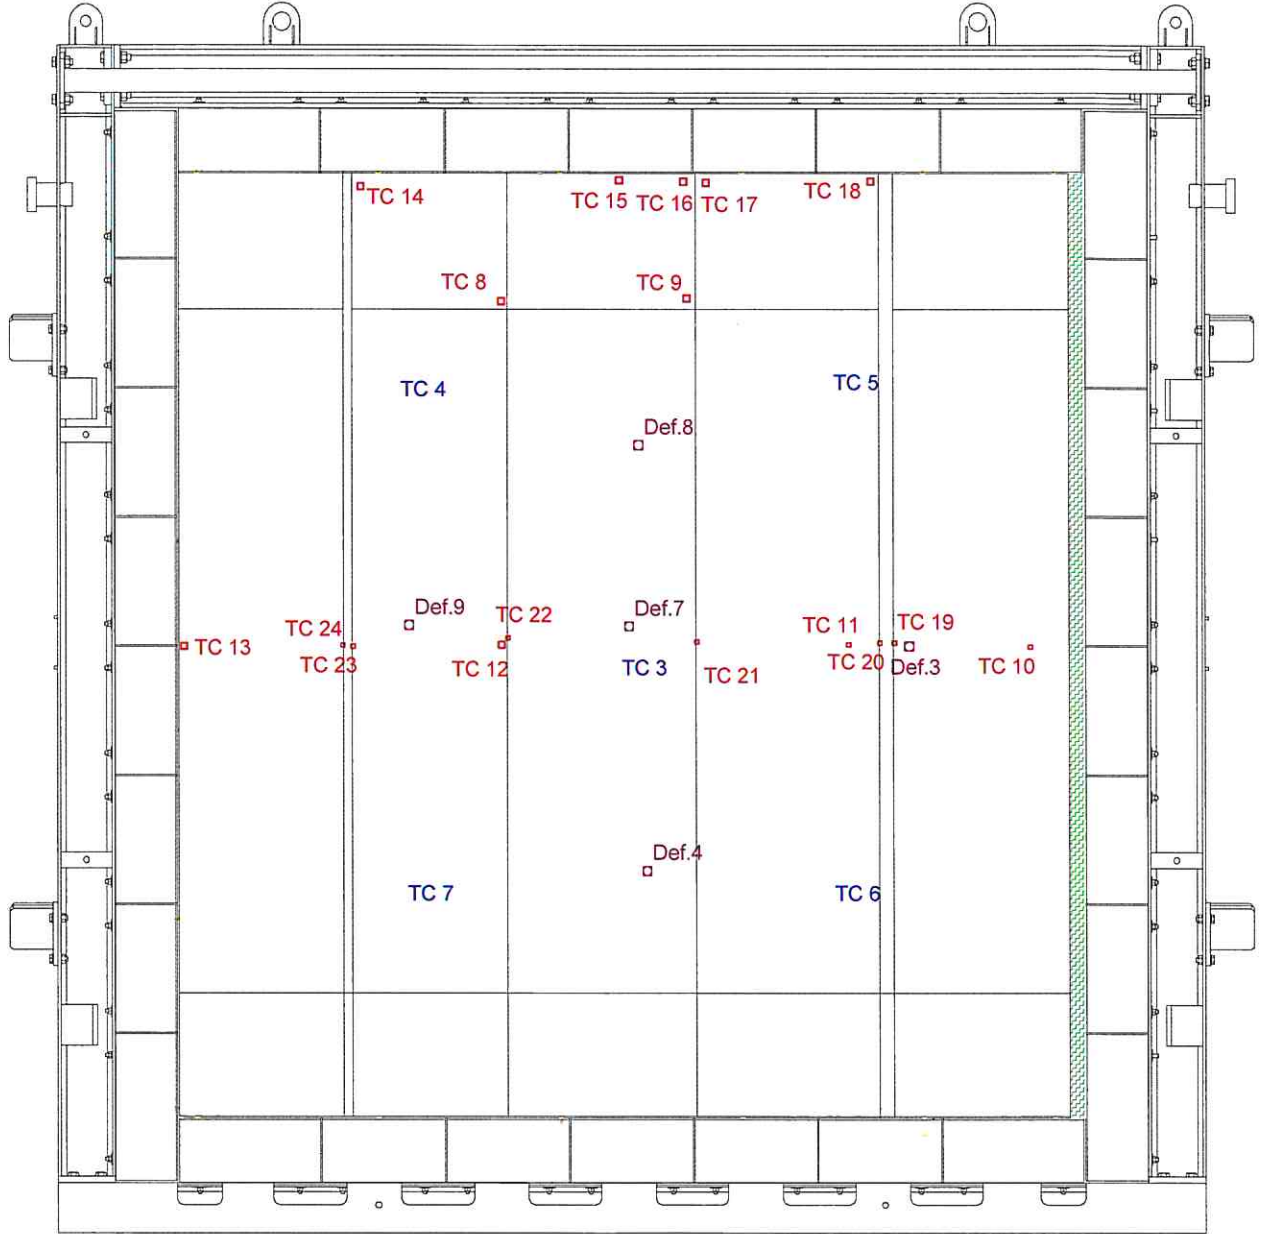
Figure B1: Locations of thermocouples and deflection sensors

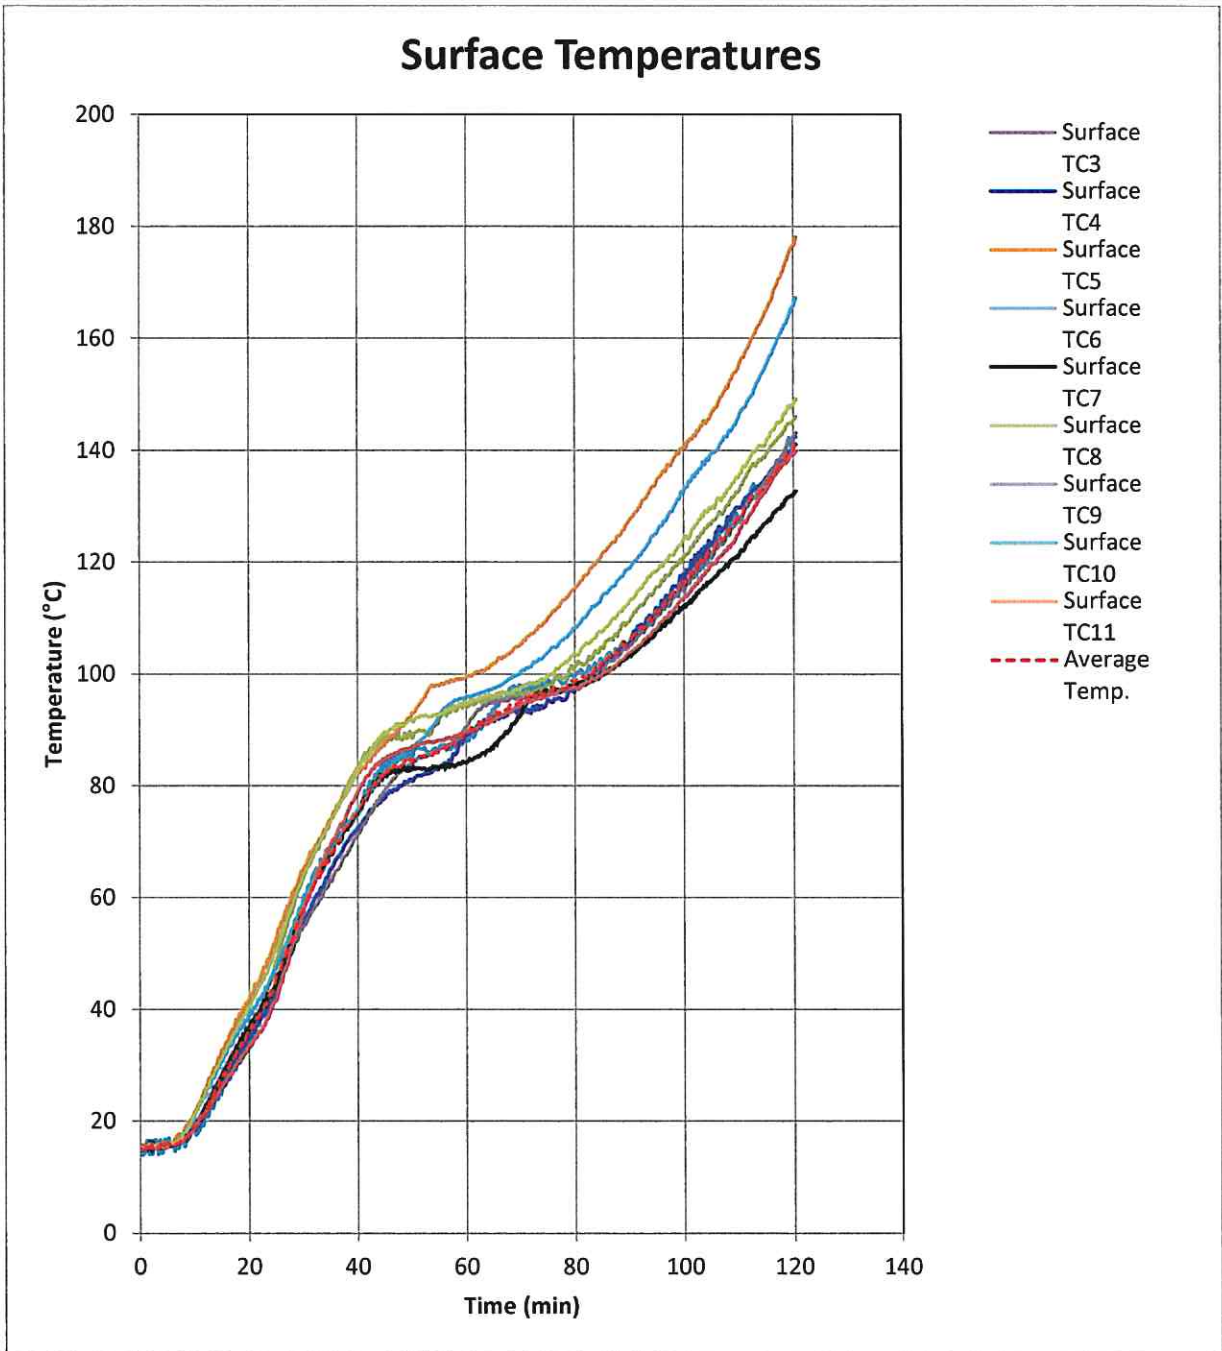
Figure B2: Surface temperatures (Thermocouple sensors for average temperature)

| Insulation:, [I]<br>- average temperature<br>- maximum temperature | no failure<br>no failure |

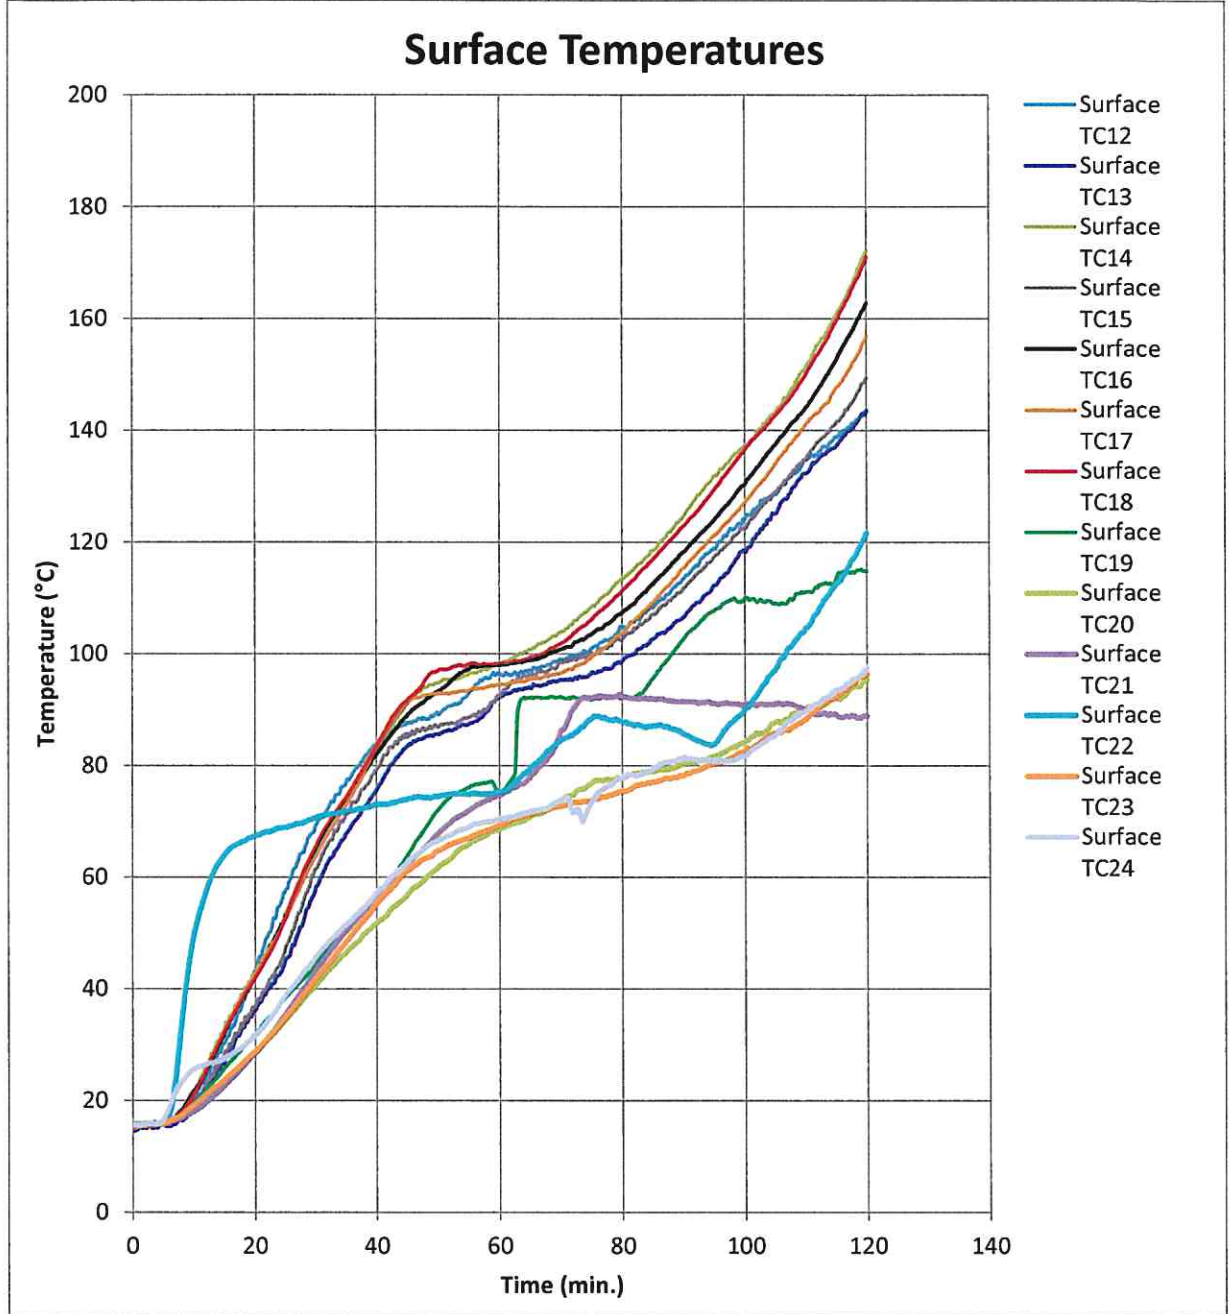
Figure B3: Surface temperatures (Thermocouple sensors for maximum temperature)

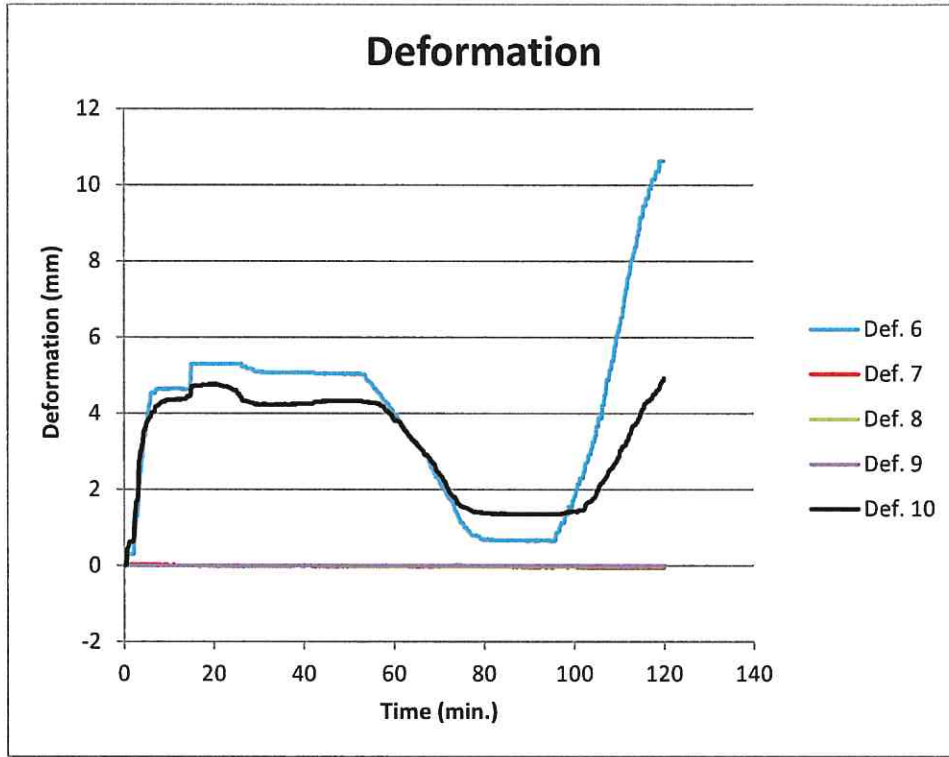
Figure B4: Deformation of the wall.

The height of the construction may be increased to 4 meters for a fire resistance of **120 minutes** for the criteria integrity and thermal insulation, because the lateral deflection of the construction is less than 100 mm. See Table B1 – Appendix B.

Table B1: Data obtained from deformation sensors

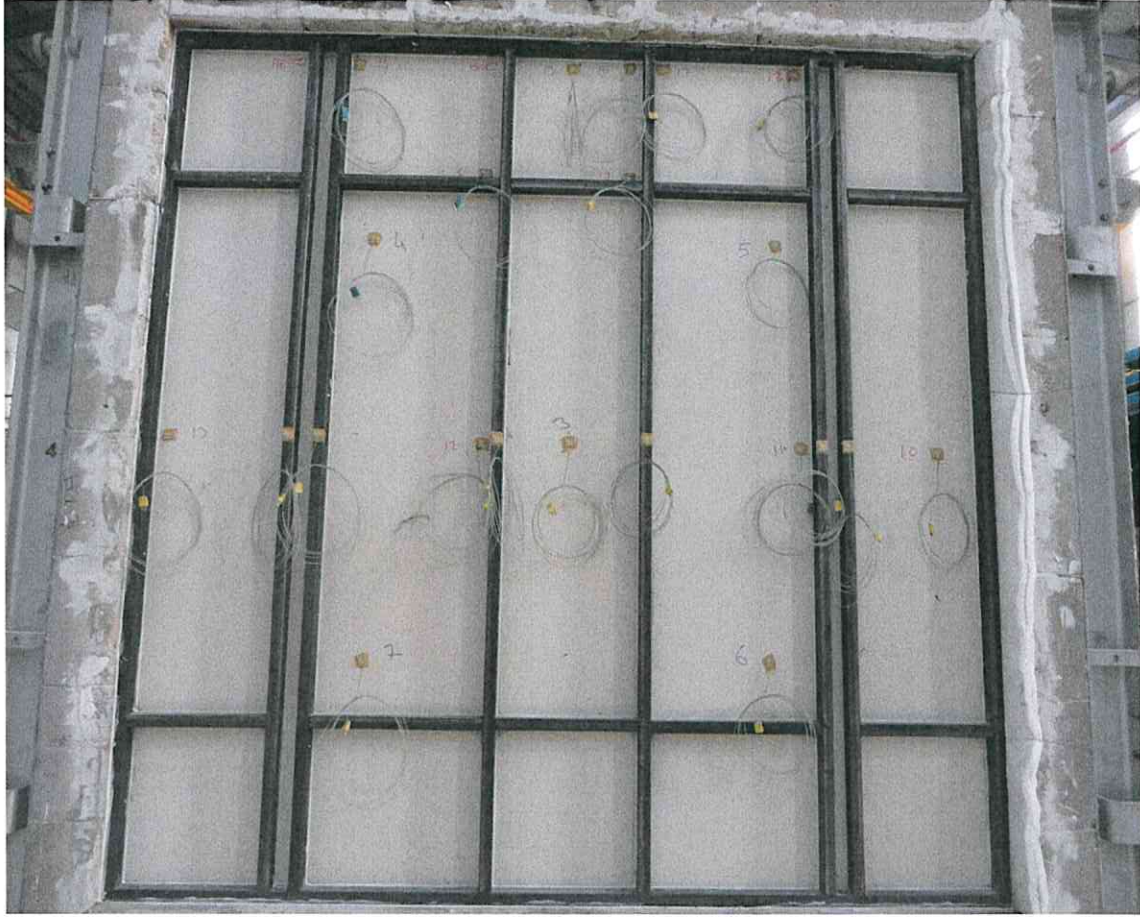
Photo C1: Unexposed side of the test specimen before the test

| 0 | Heating started. <b>See photo C1-C2.</b> |

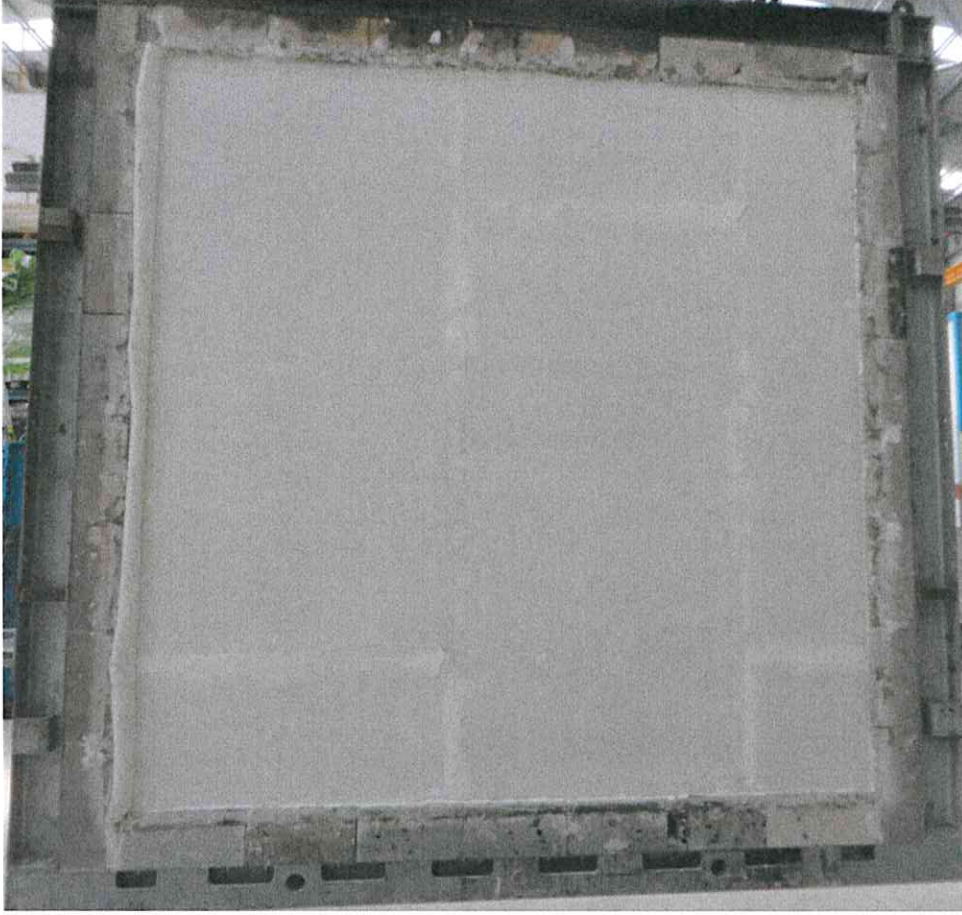
Photo C2: Exposed side of the test specimen before the test
