RFTR17166

#### TEST REPORT

**Numunenin adı ve tarifi** : Single Side Partition Wall System Consisting of Three Layer of MgO Panels –  
*Name and identity of test sample* “NevPanel, DragonBoardTürkiye, MagnumBoard”

Fire resistance test, in conformity with the general requirements of standards EN1363-1:2012, with substitute or additional methods of standard EN 1363-2:1999 and with the particular requirements of standard EN 1364-1:2015 "Fire resistance tests for non- loadbearing elements- Part 1:Walls".

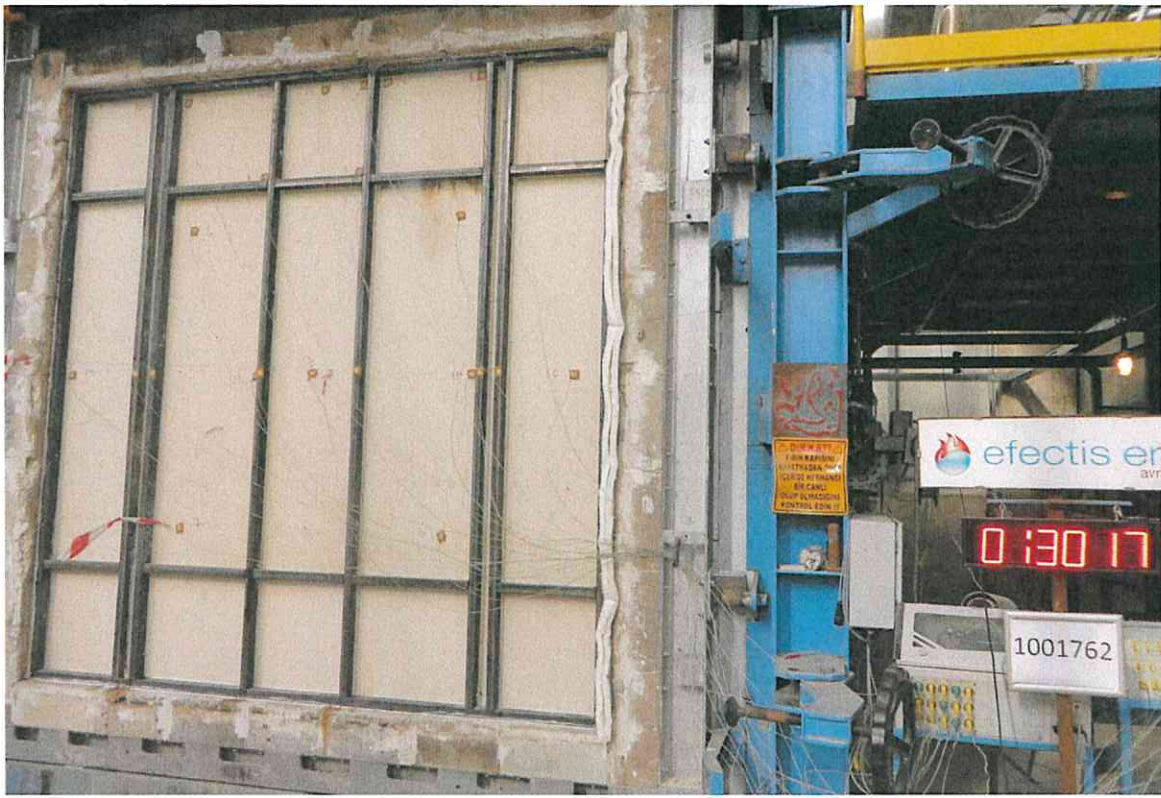
Photo C3: Unexposed side of the test specimen at 90<sup>th</sup> minute of the test

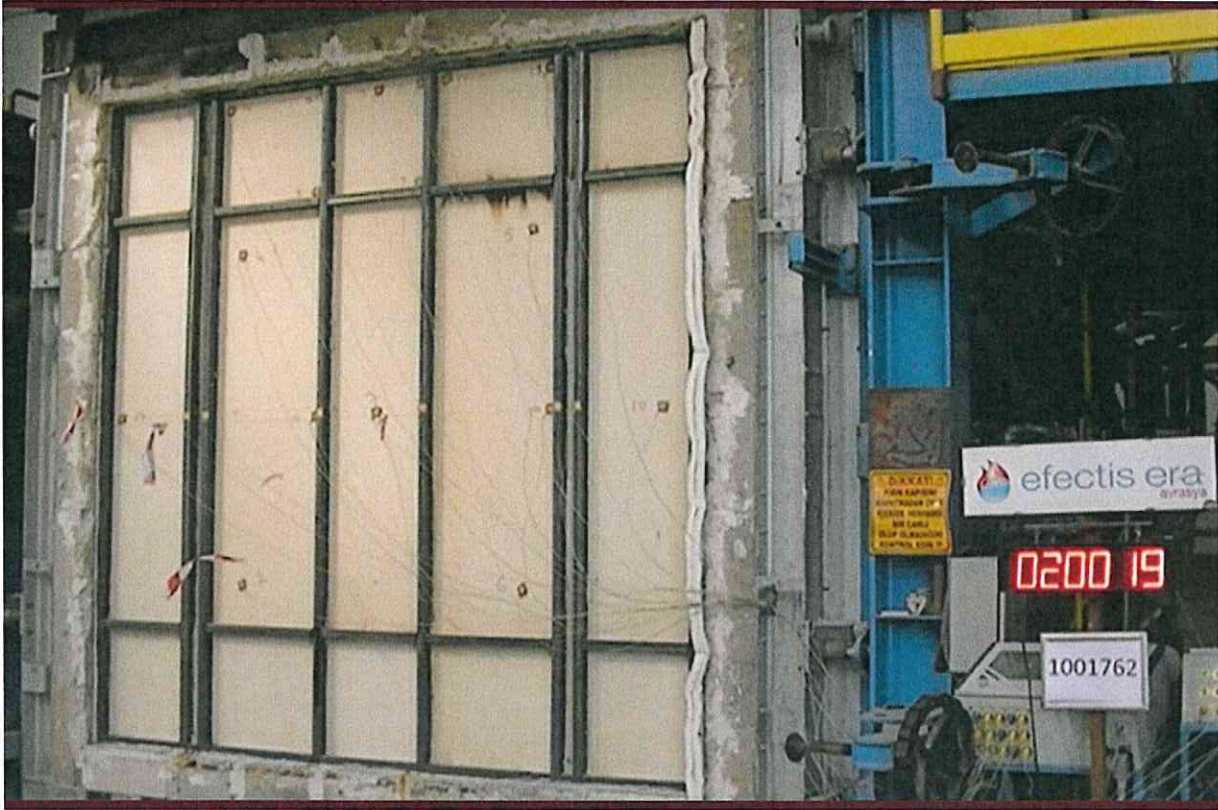
Photo C4: Unexposed side of the test specimen after the test

| 120 | Test was terminated after consulted with the sponsor. <b>See photo C4.</b> |

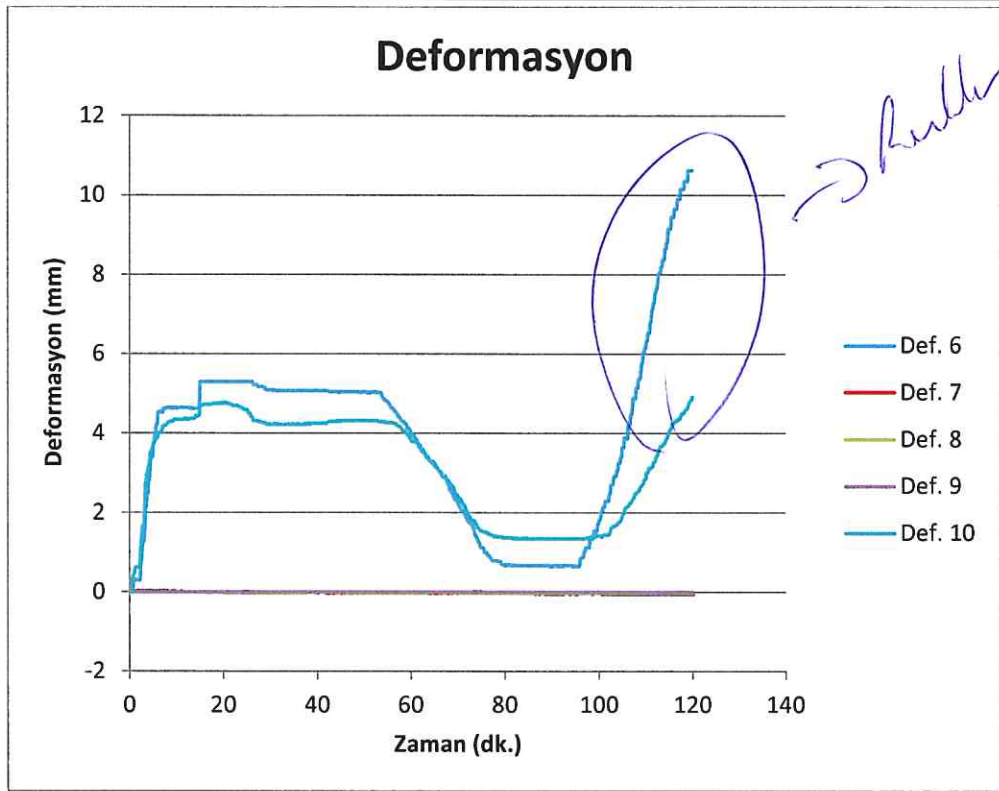
Şekil B4: Duvar sehimi grafiği.
